INVESTIGATION OF TWO METHODS FOR IMPROVING THE CRASHWORTHINESS OF INTEGRAL FUEL TANKS

FINAL REPORT

1. Report No. FAA-RD-70-56	2. Government Accession No.	3. Recipient's Catalog No.	
4. Title and Subtitle INVESTIGATION OF TWO METHODS FOR IMPROVING THE CRASHWORTHINESS OF INTEGRAL FUEL TANKS		5. Report Date November 1970

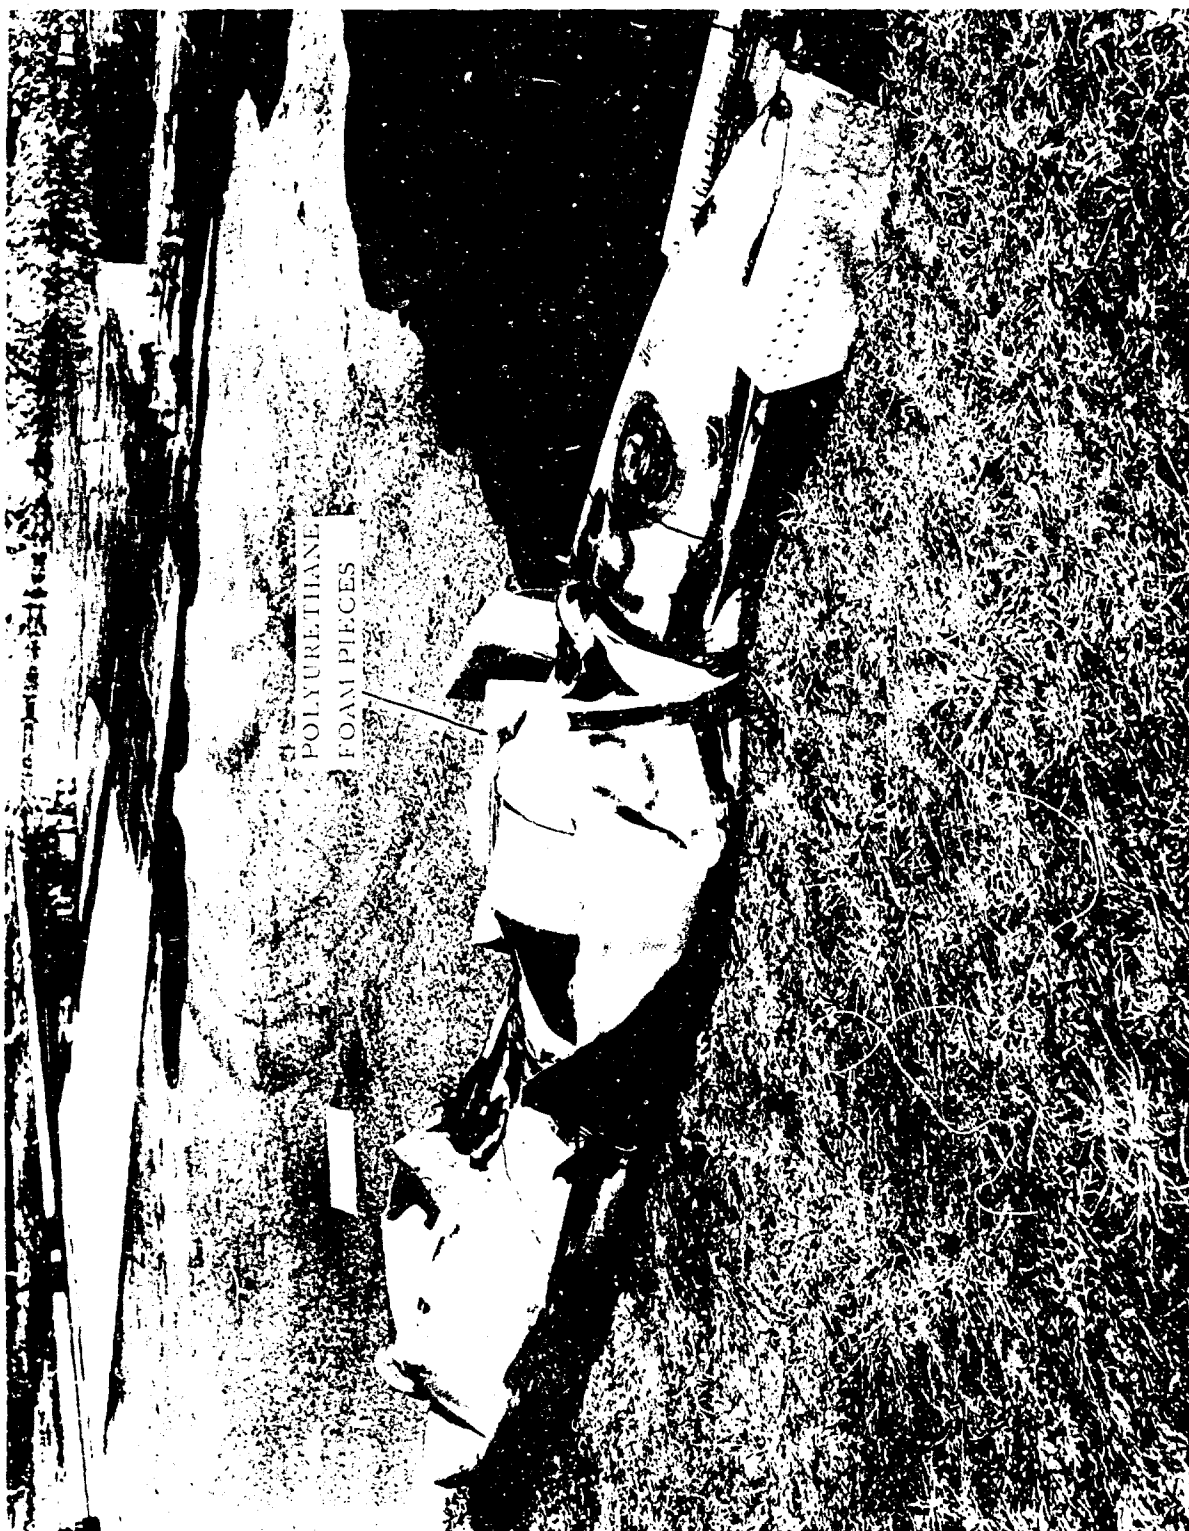
to determine the effectiveness of the foam as compared to the spray pattern obtained with the control tank that was dropped with just JP-4 inside. Figure 4 shows a typical spray pattern obtained during these tests, and Figure 5 shows the damage one tank suffered from the 35-foot fall. The photographic analysis showed that the fuel spray patterns were similar for all drops relative to the depth of horizontal and vertical areas encompassed. In an attempt to estimate the relative amounts of fuel sprayed into the air, the time for the fuel spray to dissipate was determined. These quantitative results are shown in Table 1.

FIGURE 5 F-86 FUEL TANK WITH 10 PPI FOAM AFTER IMPACT

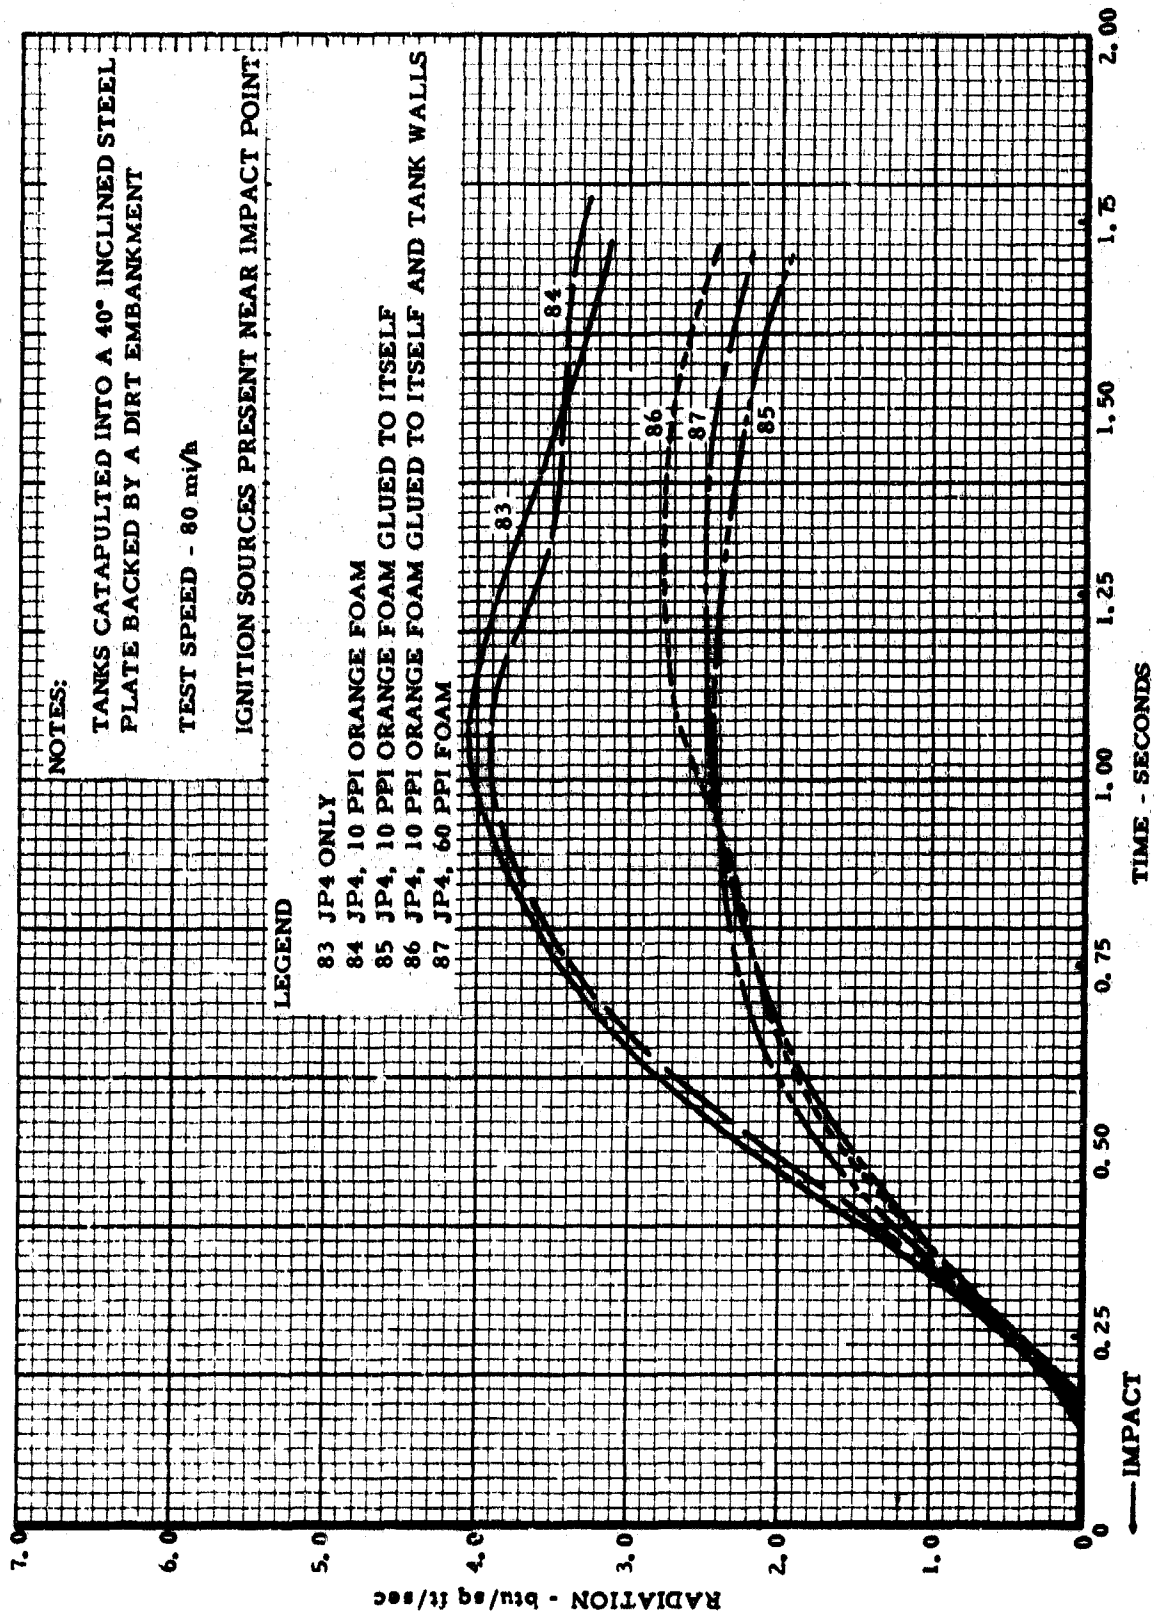
At impact the tanks broke open and the escaping fuel was ignited by burning smudge pots placed around the impact area. All of the fuel burned in the immediate vicinity of the impact area when the control tank containing JP-4 only was tested. On the other tests the fuel-soaked foam carried some of the burning fuel away from the impact area which accounts for the lower radiation readings for these tests as shown in Figure 6. Assessment of the high-speed photographs of these tests was made to determine if there was any substantial decrease in time for ignition of the fuel following impact. In all configurations tested, the fuel spray ignited within a time interval ranging from 40 milliseconds to 60 milliseconds after impact. This difference was considered to be quite insignificant.

FIGURE 6 RADIOMETER RESULTS OF F-86 FUEL TANK
CATAPULT TESTS

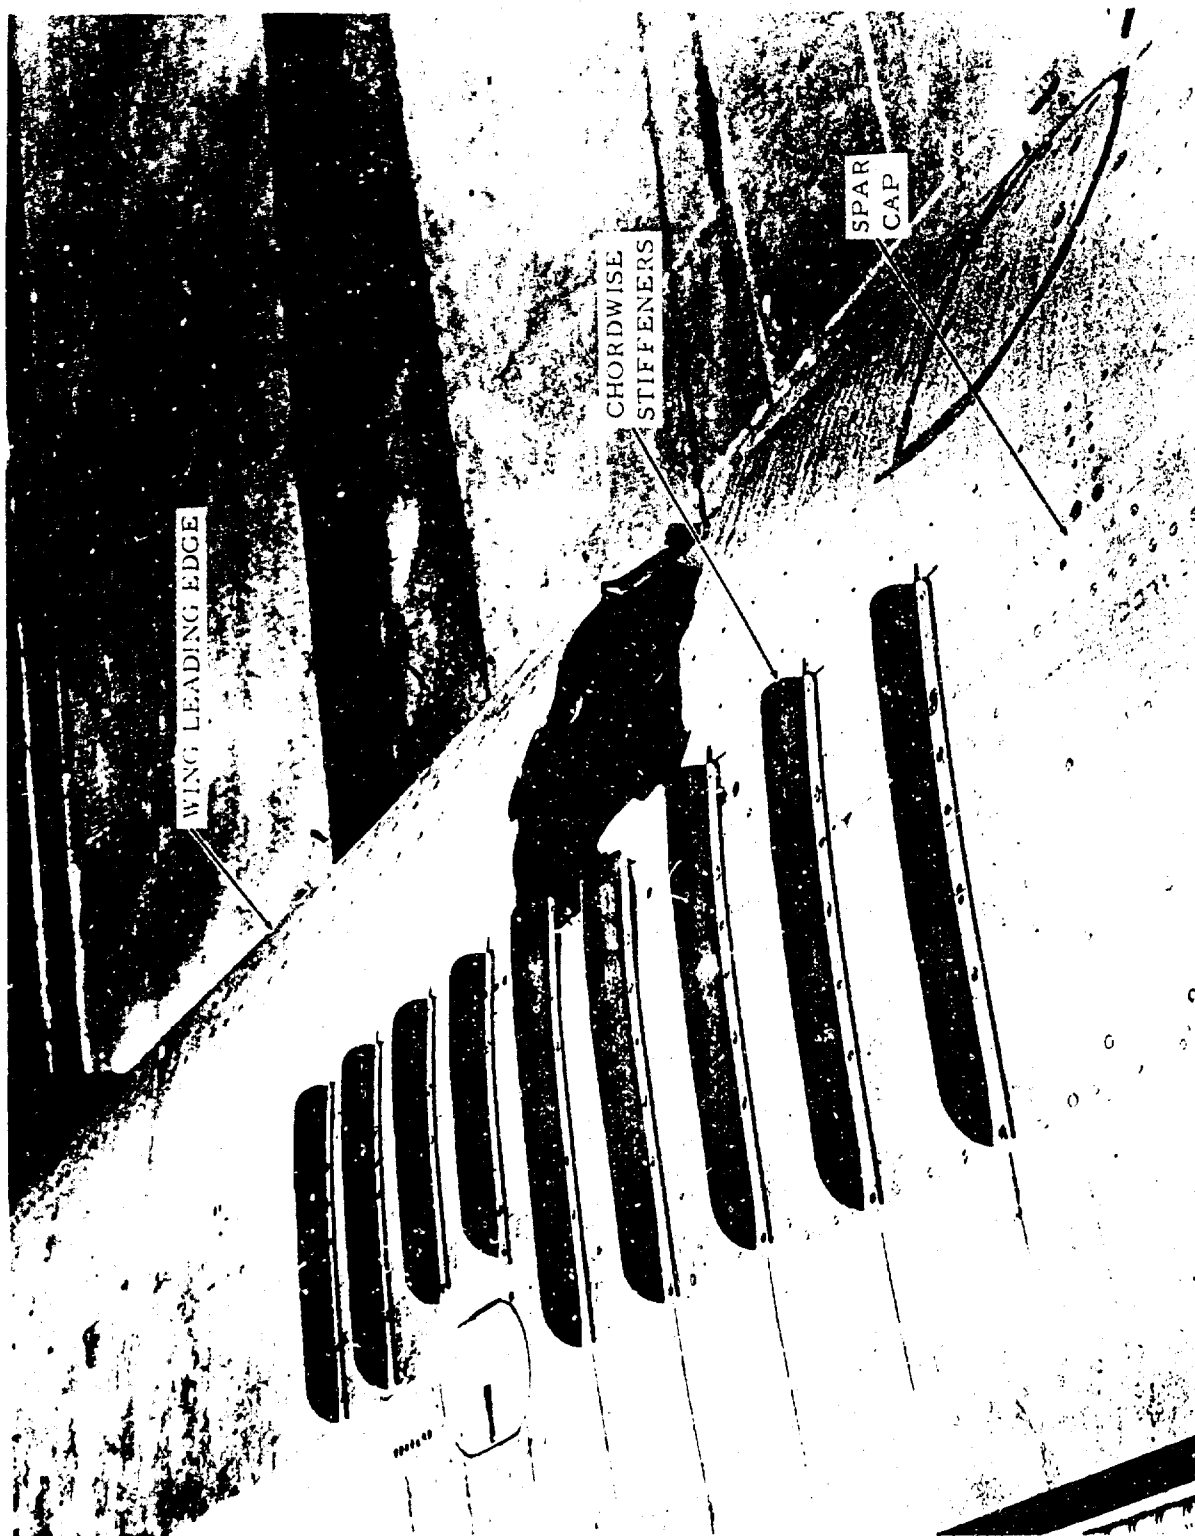
As shown in Figure 7, the tee sections were attached to the test specimen only in the immediate vicinity of the impact area. The actual weight of the tee was 8.24 pounds for this test, but extrapolation of this modification to the entire span of the outer wing panel would result in a total weight of tee sections of 45.5 pounds. The 0.020-inch-thick aluminum doubler weighed 15.5 pounds making the combined weight of structural reinforcement 61.0 pounds for the entire outer wing panel. Since the DC-7 outer panels weighed approximately 1000 pounds empty, this modification resulted in a 6 percent increase in weight. However, the 0.020-inch-thick doubler added no significant chordwise strength, and if retrofitted internal to the panel, the tees would be reduced in overall length by approximately the width of each stringer less its flange; thus decreasing the overall weight an additional increment so that at most the overall weight might be 40 pounds or only a 4 percent increase in dry wing weight.

The wing modified with the 0.040-inch-thick aluminum doubler ruptured almost as much as the unmodified control wing panel after impact, but the wing with the 0.020-inch-thick aluminum doubler and the 1 1/2-inch tee sections did not rupture upon impact.

FIGURE 7 CHORDWISE STIFFENERS ON DC-7 INTEGRAL WING TANK

2. The addition of 0.040-inch-thick aluminum alloy doubler strips aft of the upper and lower front spar caps did not appreciably increase the resistance of the integral tank structure to damage by impact. However, reinforcement of the front spar caps and internal chordwise structure between ribs such as simulated in these tests, can reduce damage to the point of preventing fuel leakage after impact.

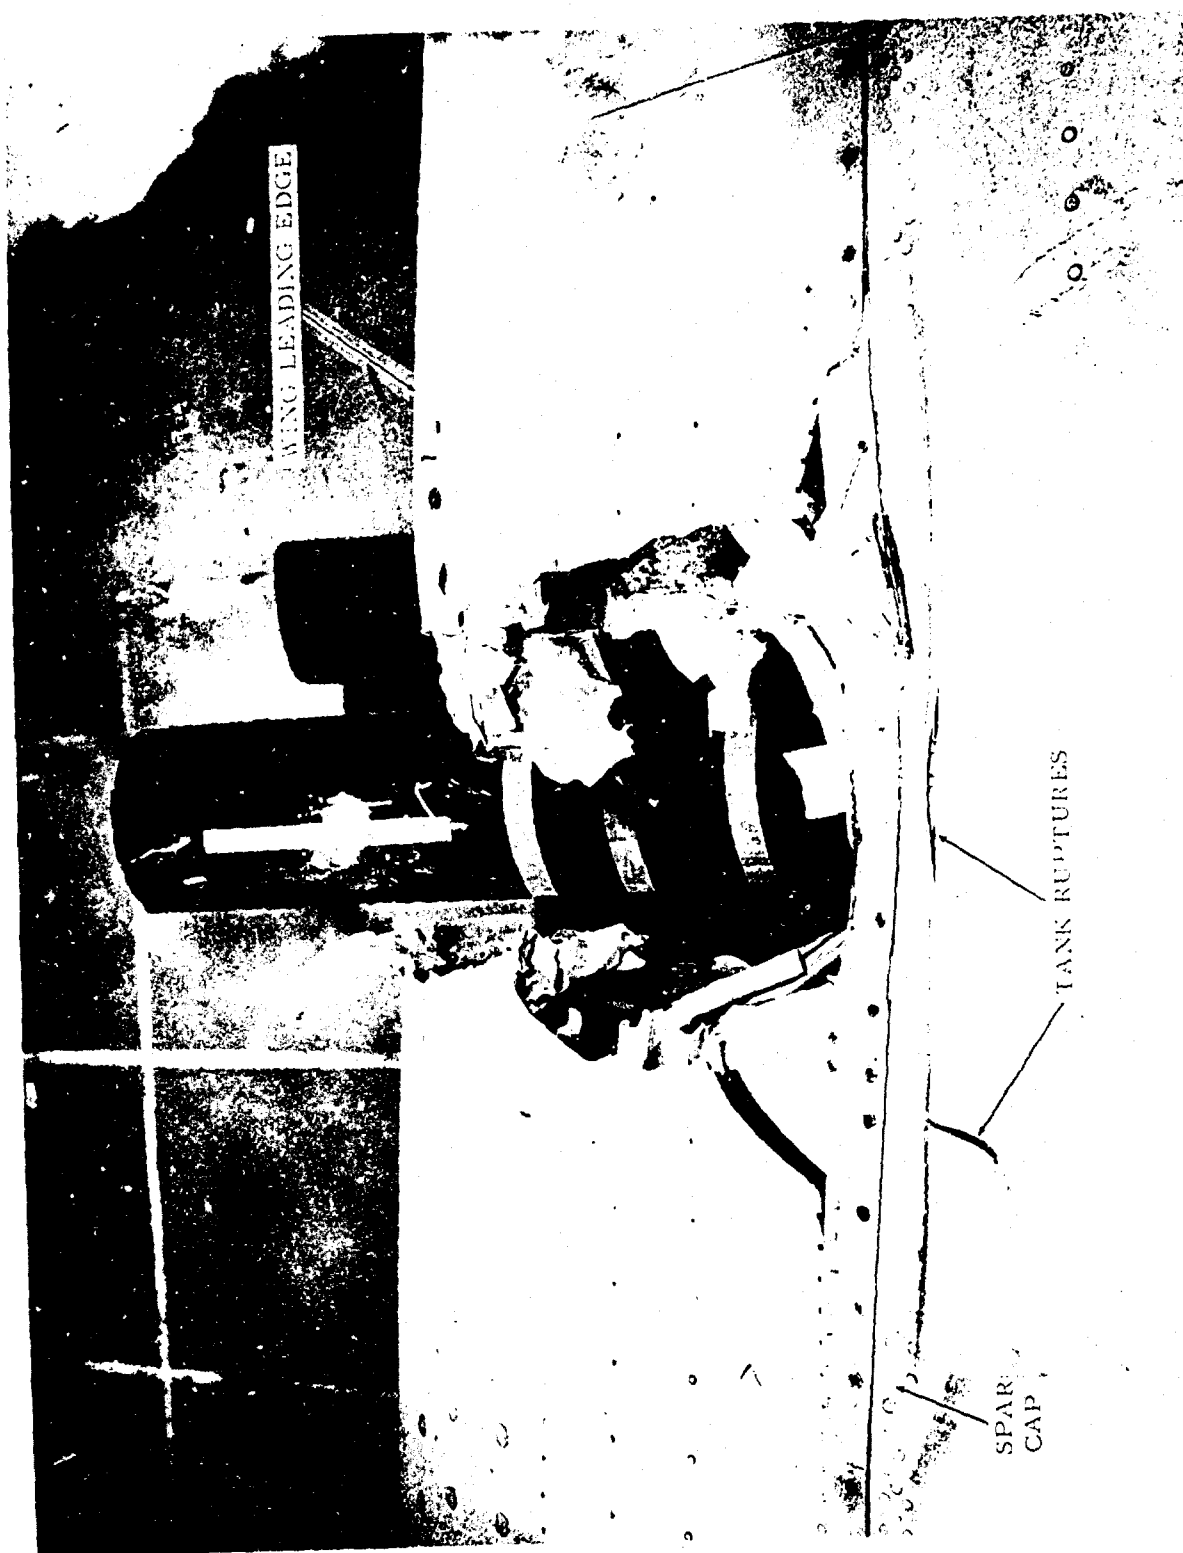
FIGURE 8 UNMODIFIED DC-7 INTEGRAL WING TANK AFTER
IMPACT
